The First Experimental Preservation Project

of the Shipwreck *SS America*

Written by
Ken Merryman
of the
Great Lakes Shipwreck Preservation Society
Fridley, Minnesota

October 20, 1997

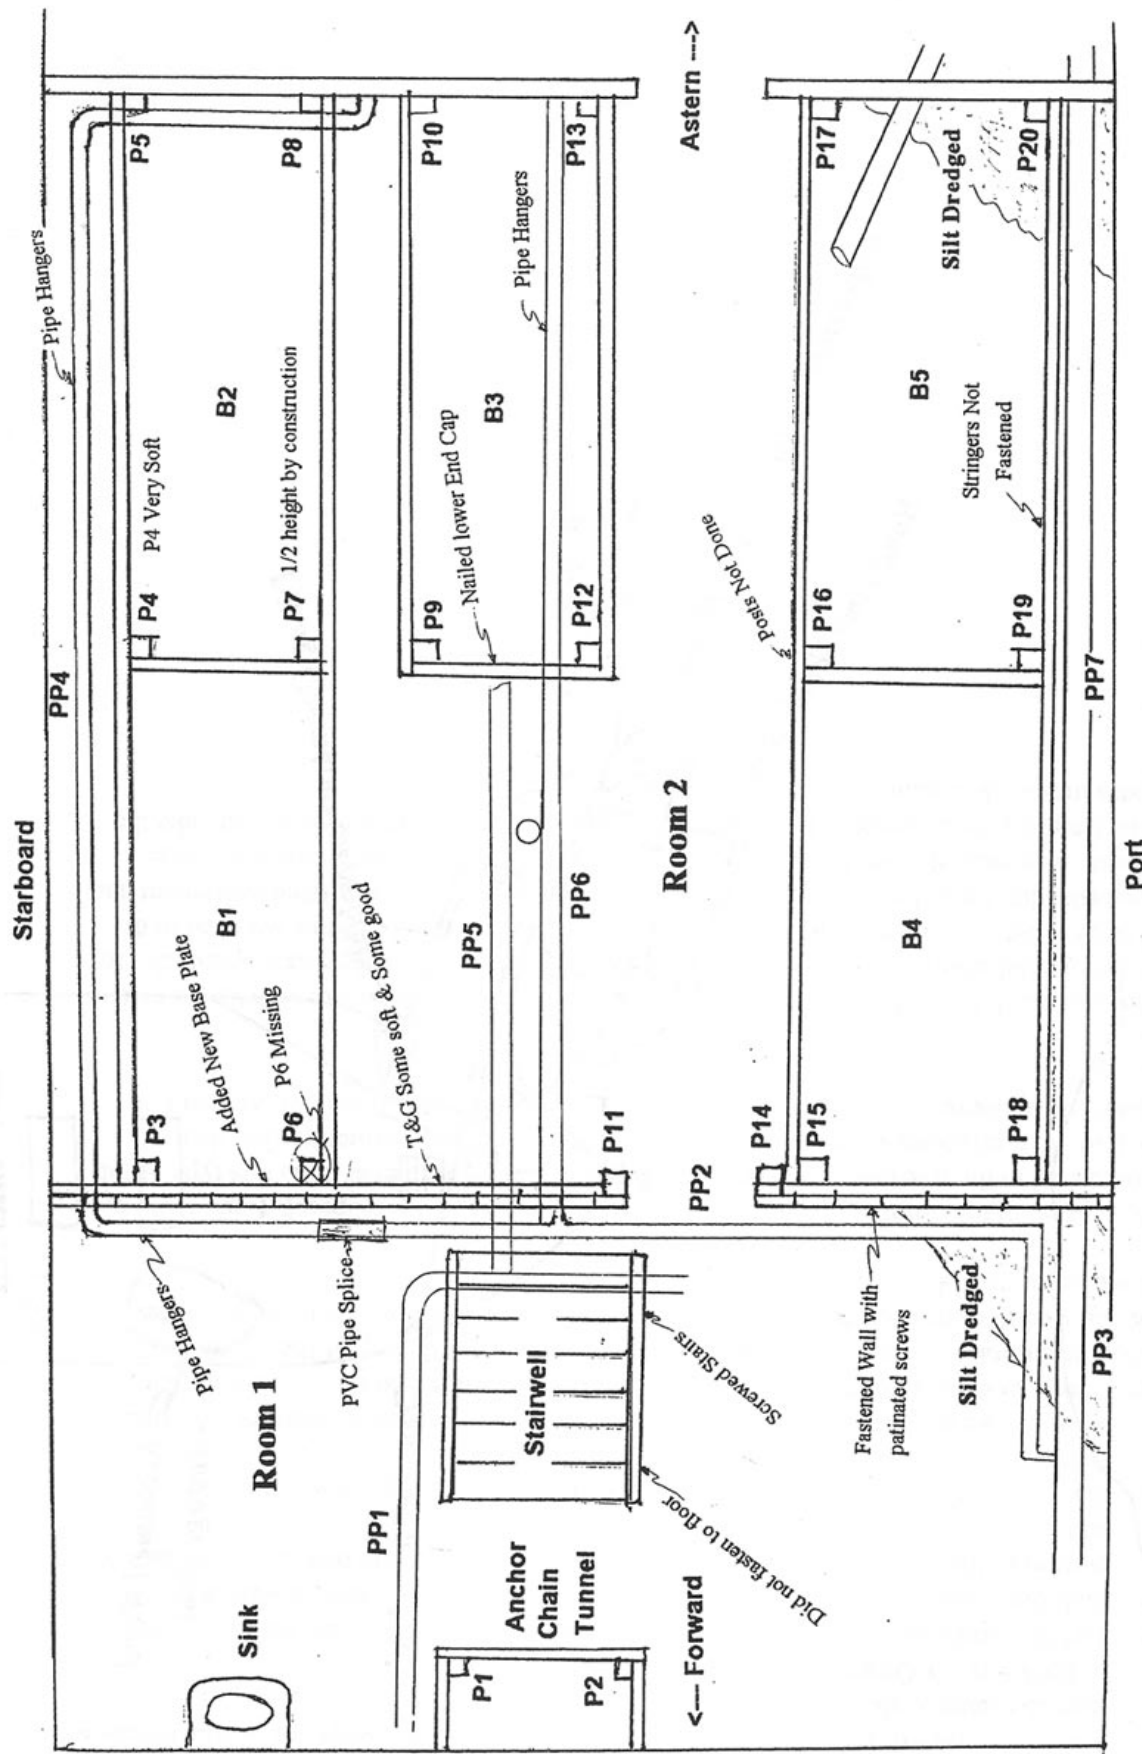
Figure 2: Documentation of Changes in the Forward Crew Quarters

Starboard side wall 1-2 was collapsed and all but the six outside tongue and groove paneling boards were loose and scattered on the floor. A new 2"x2" base plate of cedar was installed and screwed to the deck. The cross members were refastened to the posts. Posts P3, P6 and P11 were fastened top and bottom to the decks with brackets. T&G paneling was replaced as best as could be done from the pieces scattered on the floor. There were not enough full length paneling pieces to complete the wall. It is apparent that some of the board positions were made up of two pieces. There are still gaps where

Room 2 - Room 2 is the forward crew quarters. Post P6 is missing and we temporarily tied the upper bunk stringer for bunk B1 with a piece of rope to keep it from breaking off. Posts P3 through P12 were fastened top and bottom with brackets. Posts P15 through P20 were not fastened. Note that P7 is a half height post by design. Bunk stringers for bunks B1 through B5 were refastened with the exception of the outside stringers of bunks B4 and B5. The bunk end caps were replaced on B3. These end caps were fastened with bronze annular nails as a fastener test. Pipe run PP4 had collapsed and was rehung with one hanger.

- Room 2 Starboard Wall completion - Refasten tongue & groove paneling on previously collapsed wall. There are a few gaps in the wall because we could not find the matching pieces of wood. Some of the boards are flipped with the wrong side forward and the tongue and grooves of the restored boards do not fit together. We need to do the finishing work on this task. Maybe after a few months to straighten, we might be able to get the tongue and grooves to fit better. I am sure we can repair the gaps and flipped boards. This is mostly cosmetic but it will answer some questions on when and if we need to use new wood, and how reversible is the work.

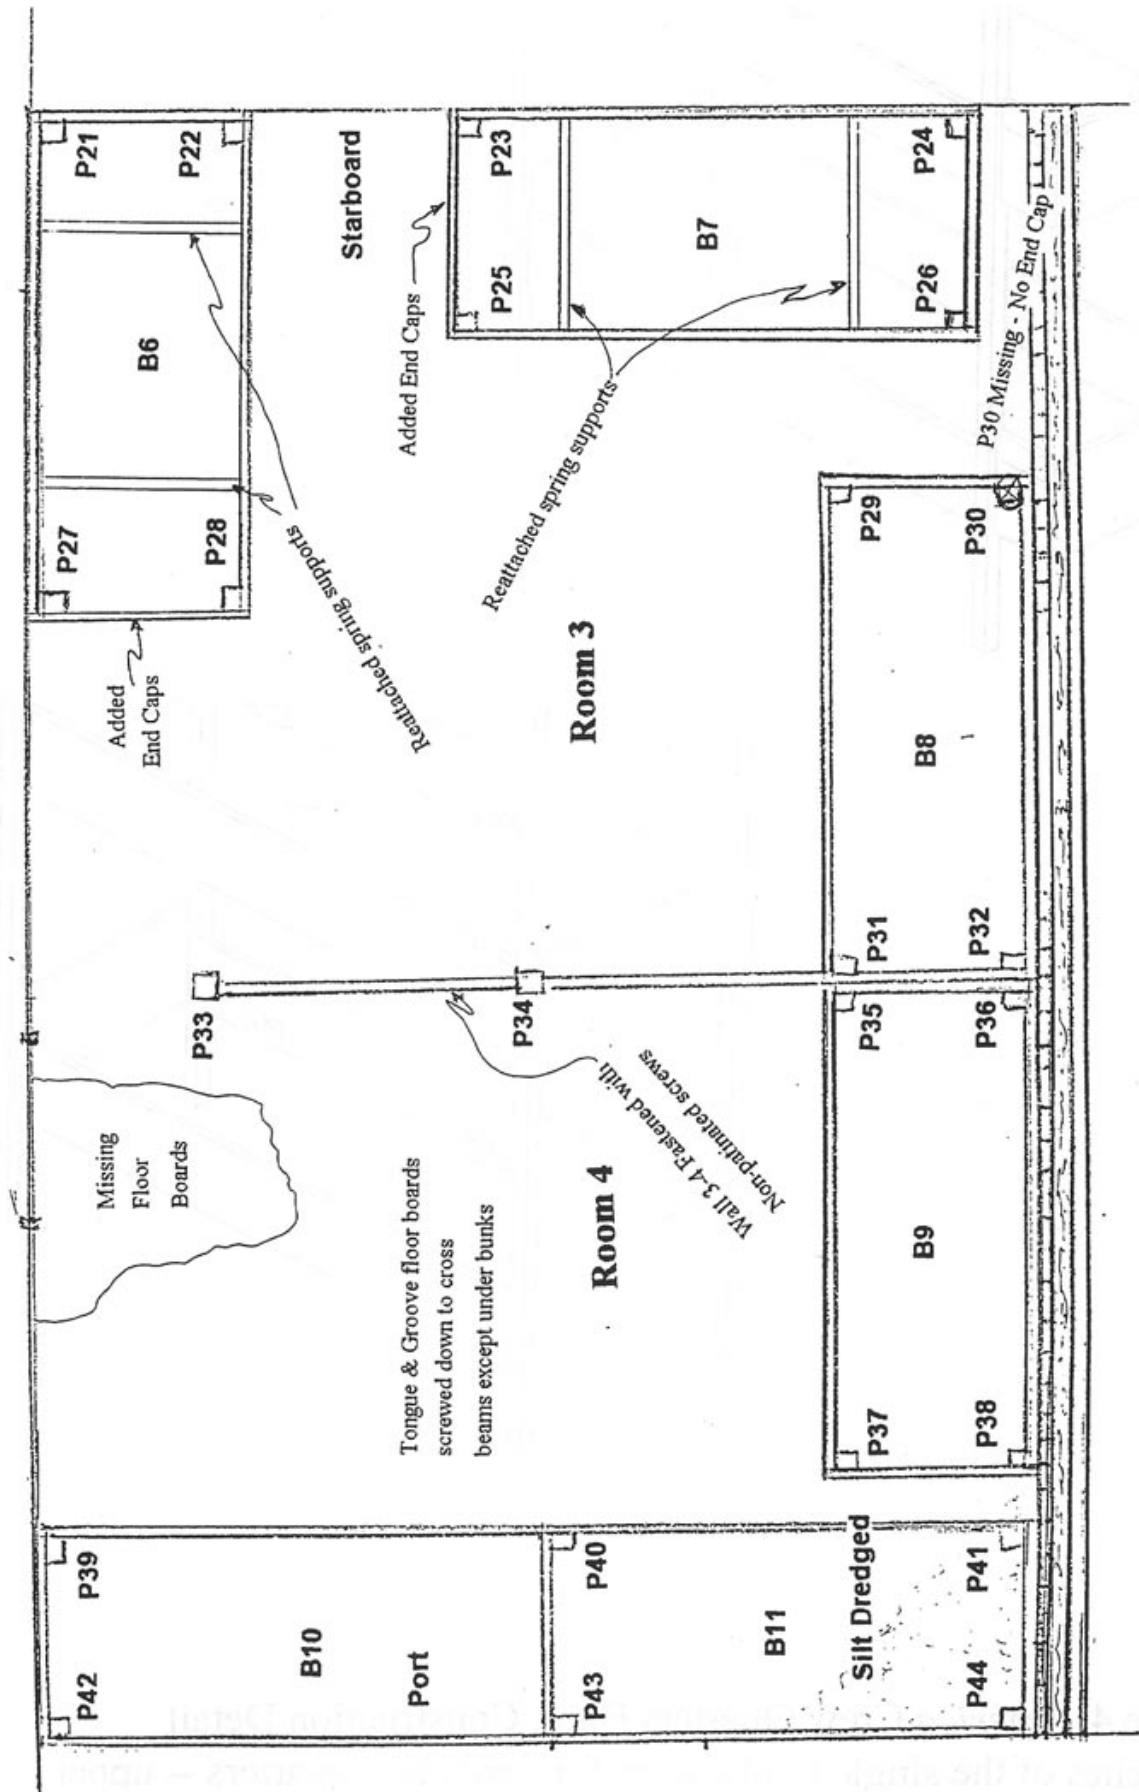
Figure 3: Documentation of Changes in the Aft Crew Quarters

Room 3 - Room 3 is the aft starboard crew quarters. Post P30 is missing. We found one post in the wood debris and I assume its original location was P30. Remaining Posts P21 through P32 were fastened top and bottom with brackets. Bunk stringers for bunks B6 through B8 were refastened with the exception of the joint on the missing post P30. End caps of bunks B6 through B8 were reclaimed from the debris and replaced with the exception of the end caps that were fastened to the P30. Bunk B7 was reconstructed to near perfect condition including spring supports. One hanger was added to an unlabeled run of conduit over bunk B7 as an experiment. No changes were made to the aft wall between Room 3 and the cargo hold. No silt was dredged from the aft port corner of Room 3, but should have been. We missed that corner. Many of the pieces of the bunks in this room were reclaimed from the corner.

Room 4 - Room 4 is the aft port side crew quarters. Posts P39 through P41 were fastened top and bottom with brackets. Posts P33 through P38 and P42 through P44 were not fastened. Bunk stringers for bunks B10 and B11 were refastened with the exception of the outside stringers of bunks B10 and B11. Stringers on bunk B9 were not done. The bunk end caps were not replaced on B9 through B11. The deck boards except under the bunks were fastened down to stabilize the floor from coming apart around the hole in the floor. The wood around the hole is very soft, and I do not expect this stabilization to last very long. Wall 3-4 was stabilized in its forward half with one row of screws through the T&G paneling that was still in place. This wall was done with plain unpatinated screws as the patination test control group. The T&G paneling on the aft half of the wall is loose and will require careful placement before fastening. A new base plate will also need to be added. No changes were made to the aft wall between Room 4 and the cargo hold. Silt was dredged from the aft port corner of Room 4. Much of the wood from all of the rooms was reclaimed from the aft port corner of this room.

- Fix hole in floor in room 3 - The floor is very loose and needs to be fastened down to avoid further deterioration. We proposed fixing the hole in the floor of the back crew's quarters in the 1996 project. We made an attempt to do this but the wood was too soft for just screws to hold. After thinking about it, I believe we can fix it by adding a wooden strip over the top of the boards that can be screwed into the deck beam. This should really be done before we loose all of the flooring in room 4.

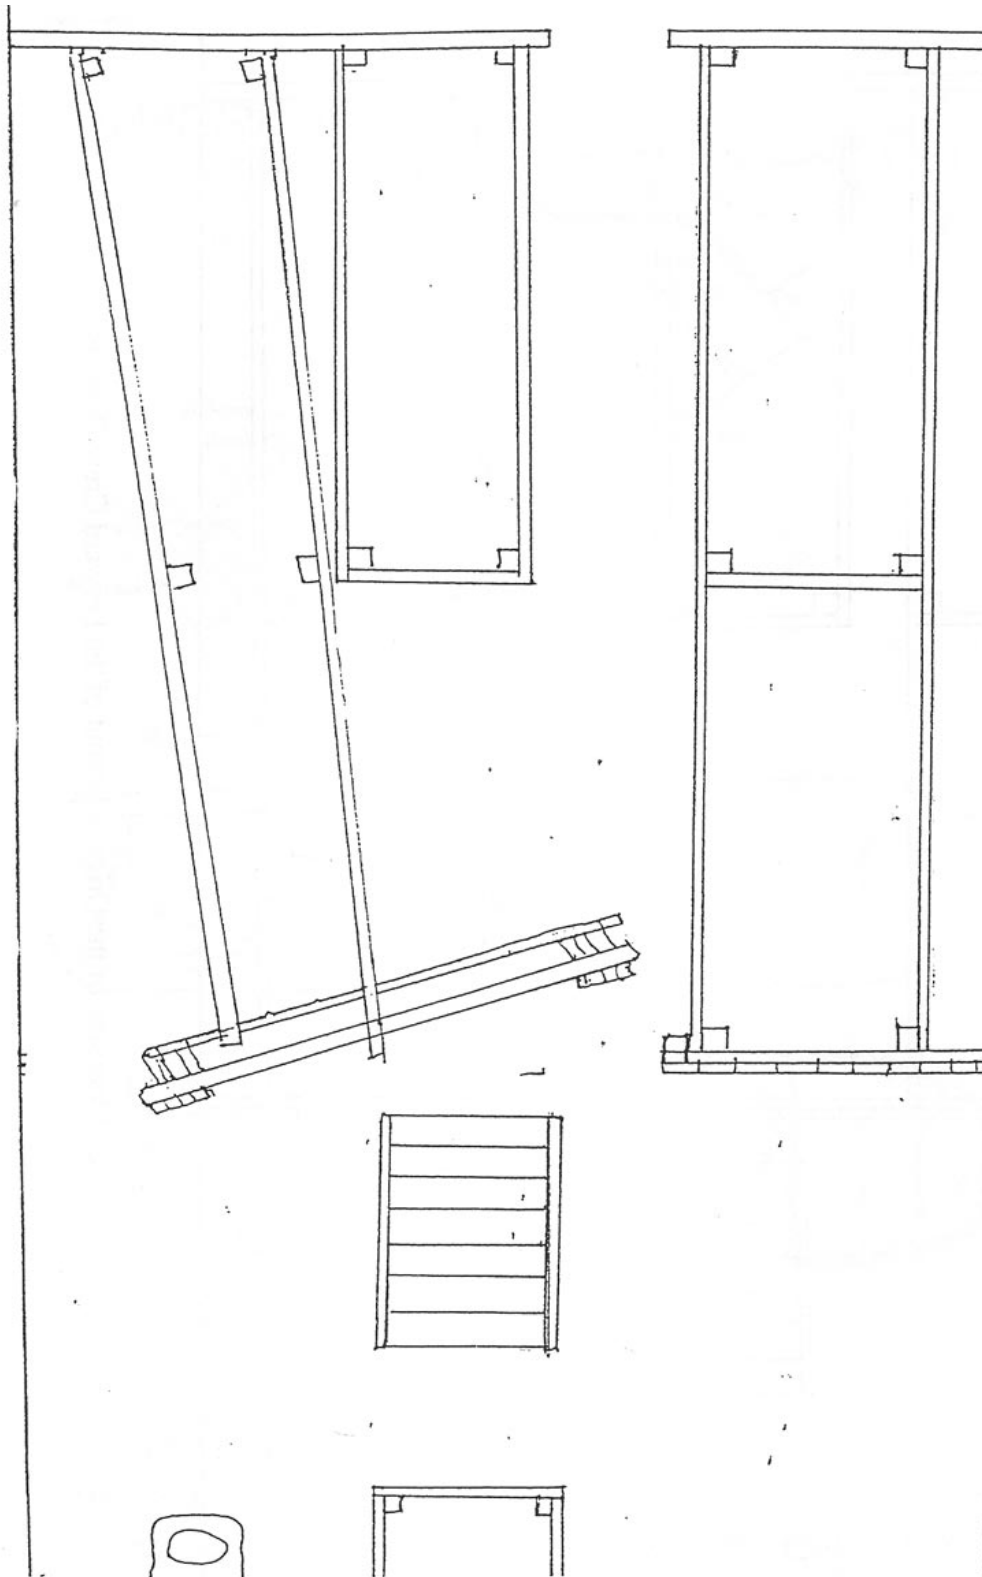
Figure 3. Floorplan of the Current Condition of the Forward Crew Quarters showing the Collapsed Wall and Moved Bunks.

After the forward wall collapsed the attached bunks also toppled leaving the deck area looking more like the above drawing.

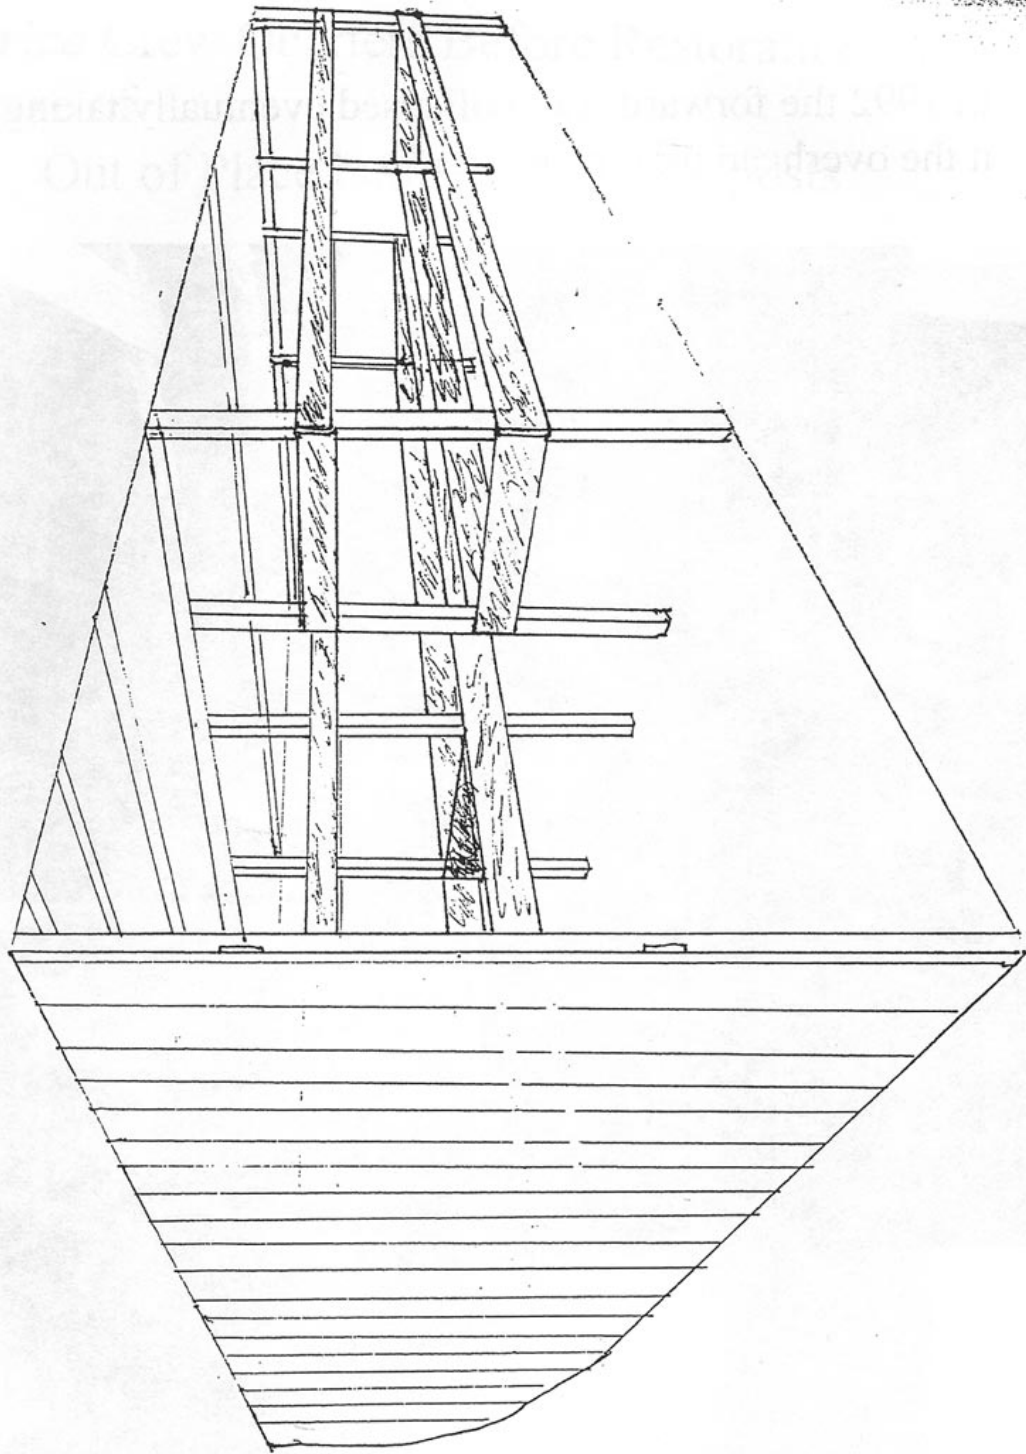
Figure 1. Perspective Drawing of the Original Layout of the Starboard Side Forward Crew Quarters

In 1992 the forward wall collapsed eventually taking with it the overhead piping and bunks.

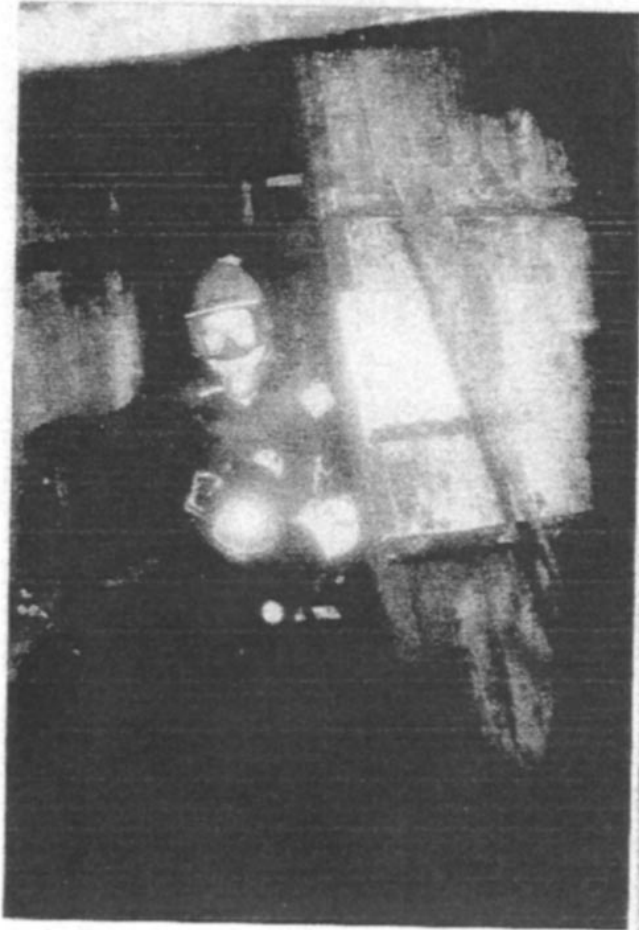
The maze of debris made it difficult to retake the photo from pre 1991 since every movement the photographer made in the room created entanglements that stirred up the silt. This is however the same perspective as the photo on the left.
