The First Experimental Preservation Project

of the Shipwreck *SS America*

Written by
Ken Merryman
of the
Great Lakes Shipwreck Preservation Society
Fridley, Minnesota

October 20, 1997

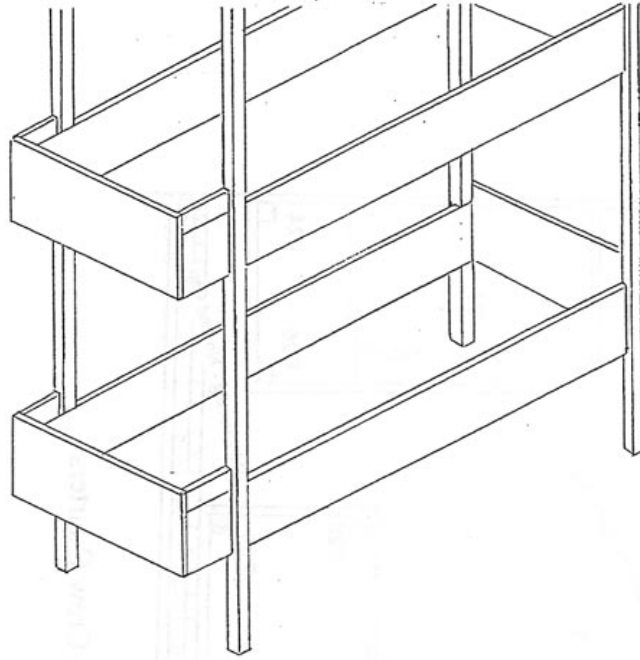
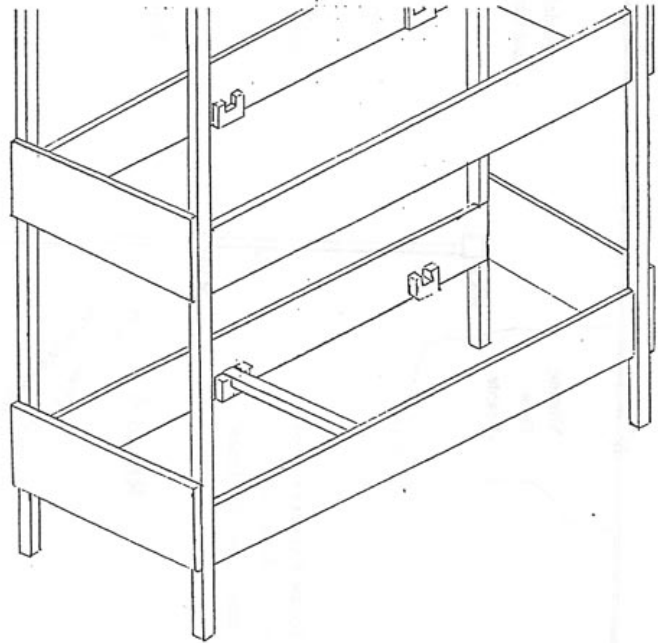
Figure 4 *America* Crew Quarters Bunk Construction Detail
(Sketches of the single bunks from forward crew quarters -- upper
and aft crew quarters -- lower)

See the figures 2 and 3 for pictorial documentation. Also note that the correct bunk construction details are shown in figure 4. It differs slightly from the deck plan diagrams.

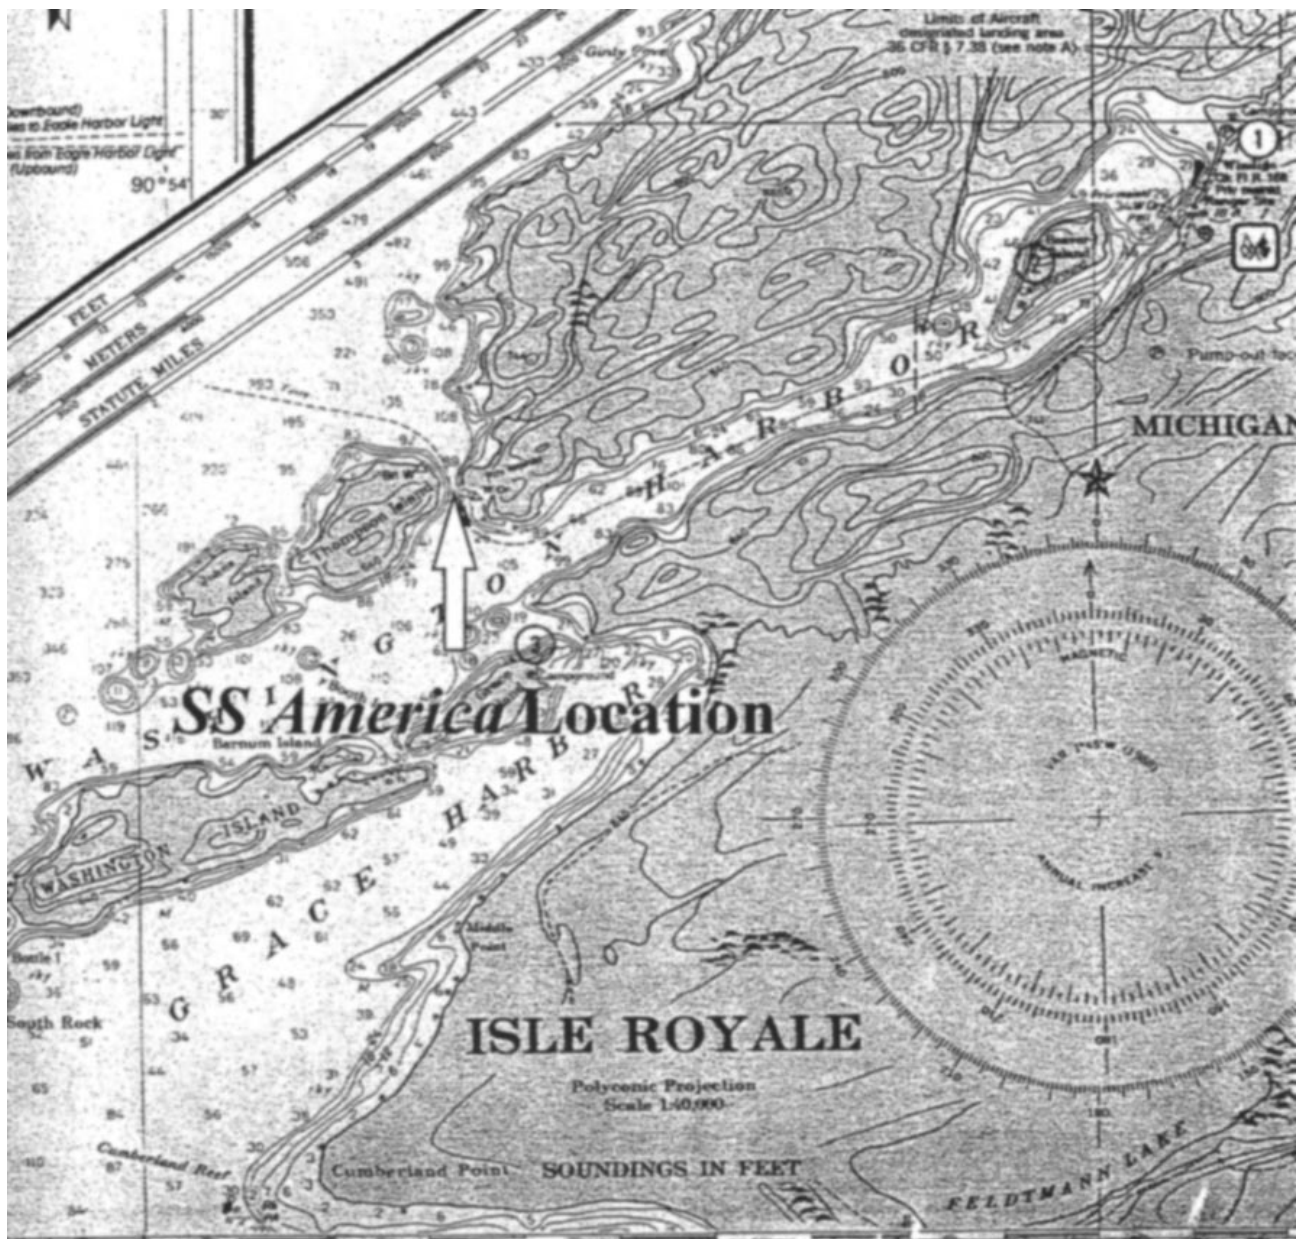
The 182 foot SS America sank June 7, 1928 in the fog with no loss of life. It lies in 2 to 70 feet of water in North Gap of Isle Royale near Washington Harbor. The site is relatively sheltered from the open seas of Lake Superior. Now divers visit this underwater historic attraction on 500 dives per year. At this level of usage it is easy to see why the fragile structures are deteriorating.

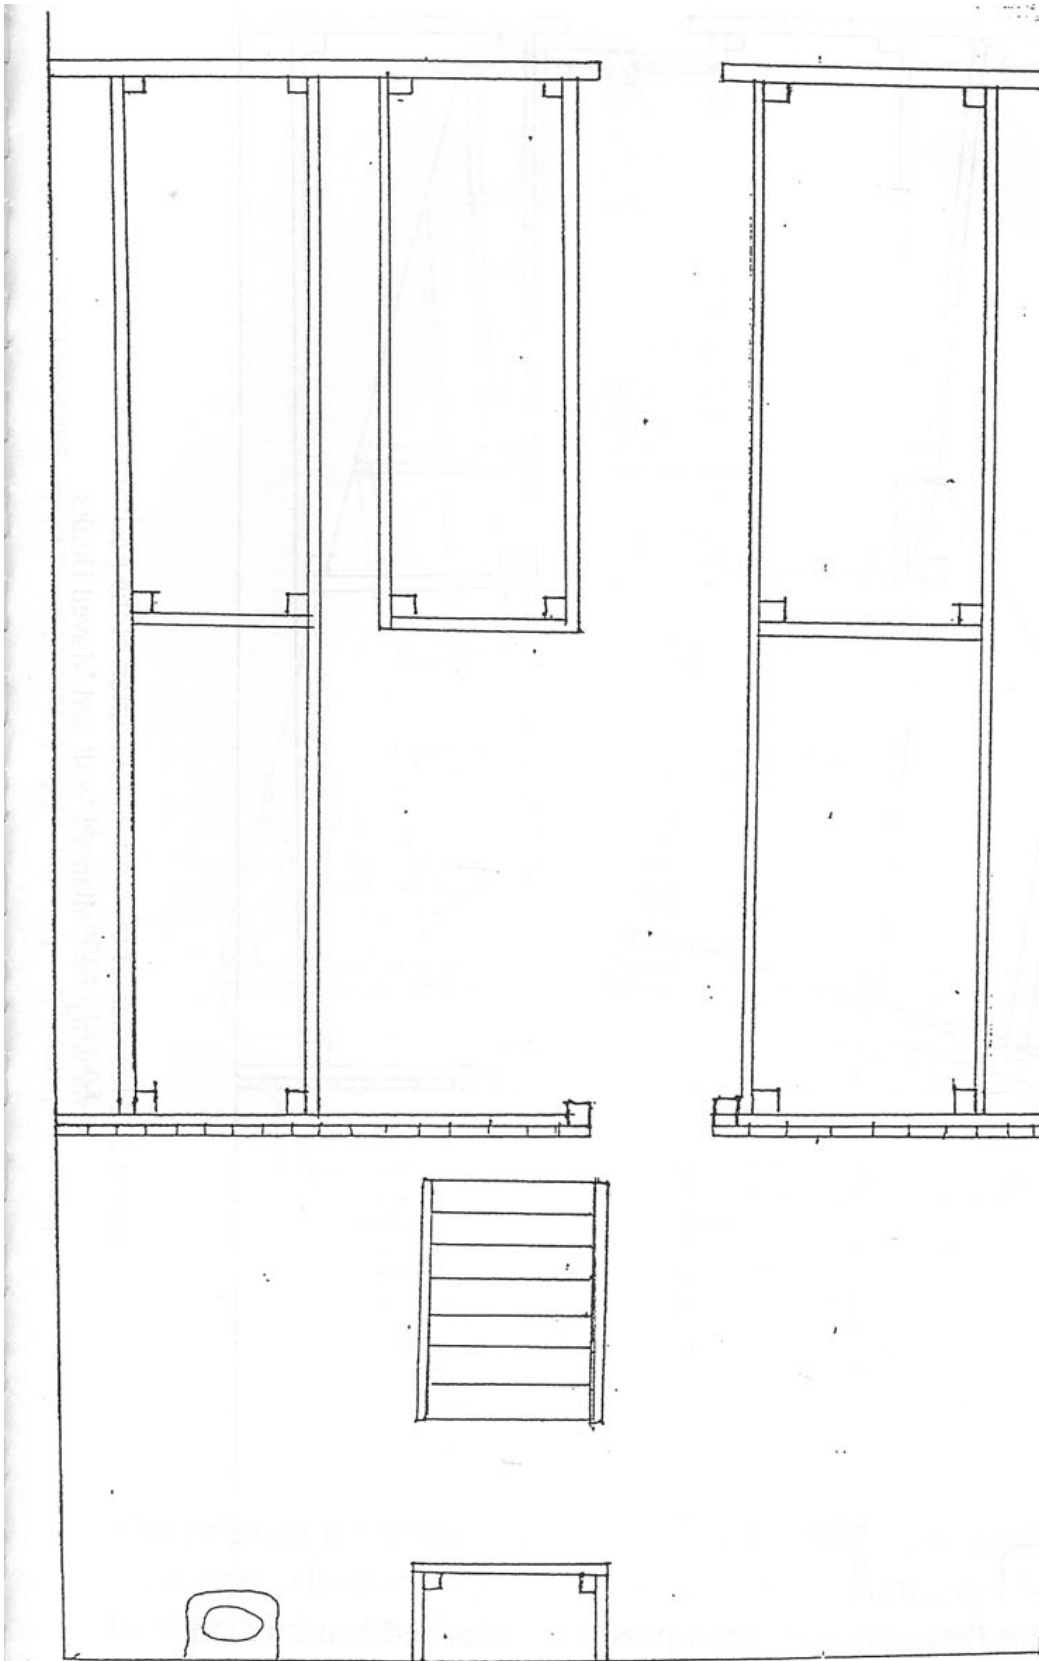
Figure 2. Floorplan of the Original Layout of the Forward Crew Quarters

The deck plan of the crew quarters shows the original layout of the bunks and walls.
